SUBSURFACE DISPOSAL OF MINE WATER

Robert Stefanko

The Pennsylvania State University
University Park, Pa.

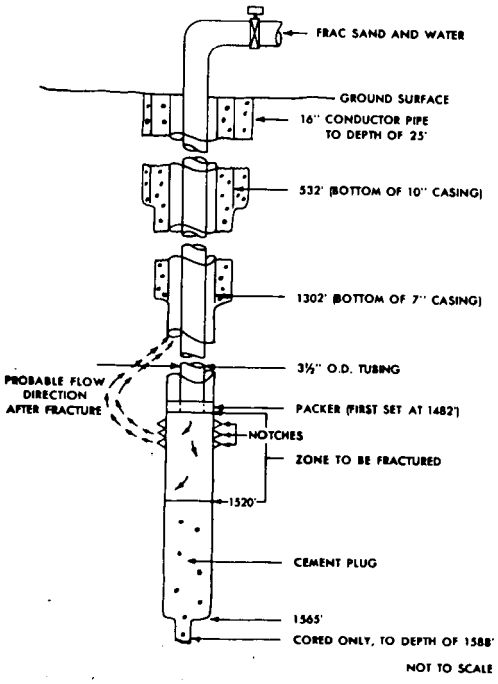
Figure 2

psig until the treatment was about 75 per cent completed. At this time water was observed flowing out of the top of the well from the annulus between the seven-inch casing and the three and one-half-inch tubing. This flow was continuous and increased in volume. The fracture treatment was concluded after 34,000 pounds of sand and 26,000 gallons of water had been pumped into the well as the benefits to be derived from further pumping were dubious. This leak indicated that water was entering the formation, by-passing the packer, re-entering the well bore and flowing to the surface, Fig. 2. An induced vertical fracture, which bridged the packer, would cause this type of flow pattern. The possibility of a wash-out around the packer seemed unlikely, as the rock at this depth appeared competent enough to withstand rapid erosion.

CONDITION OF WELL DURING SECOND FRACTURE TREATMENT

After the pressure had been bled off the well, the packer was unseated and reset at the depth of 1480 feet in an attempt to isolate the entire fracture. Fresh water injection was resumed after the packer had been reset. The flow rate varied from 145 to 160 gpm and the pressure ranged from 1600 to 1700 psig. After 12,700 gallons of water had been injected, water again began to flow out of the annulus at the top of the well. Injection was halted and the packer was raised and reset at the depth of 1472 feet. Injection into the well began again at the rate of 150 gpm. The pumping pressure ranged from 1600 to 1800 psig. After the injection of 18,400 gallons of water, the leak recurred and the injection test was stopped. No further attempt to relocate the packer at a higher elevation was made, as the caliper log indicated the upper well bore was unsuitable for this purpose.
